Manhole Inspection Summary

Manhole # S01EE2002MH

Insp Date: **7/21/06 7:35 AM**

Location Address: **6228 BENHURST RD**

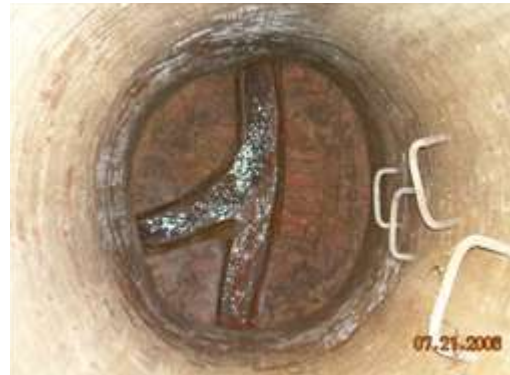
Top View

☒ **Debris** (not Condition related)

☒ **Evidence Of Surcharge**

Depth: **1** (ft.) ☐ Active Surcharge Present

Evidence of surcharge - Bench debris.

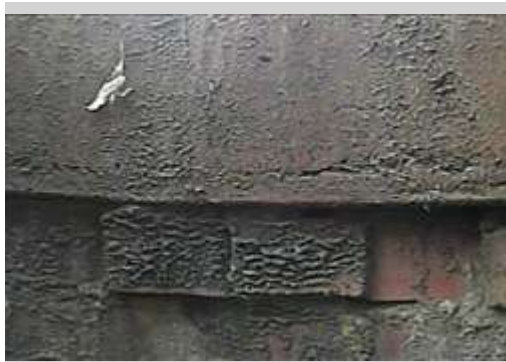
Defect

☒ **Leaks**

Infiltration: ☐ None ☒ **Joint** ☐ Cracks ☒ **Mortar** ☐ Roots ☐ Wall

Frame leaks. Adjustment infiltration.
